Laser Etching Past Quality History

Wire Harness Production Management Business Unit
Quality Assurance Department
Supplier Quality Department
Component Evaluation Group
3/6/2024

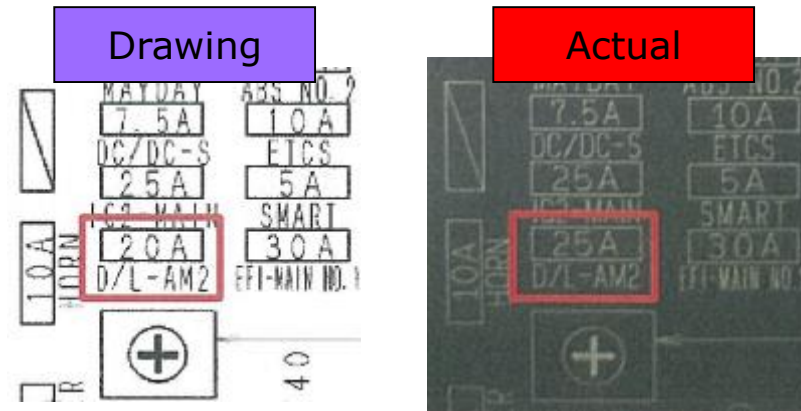
2. CASE STUDY 1

Defect : Wrong character

Defect quantity : 21 pieces

*In fact, all specific lots are out of spec.

During the start-of-work inspection, a misalignment in the etching position was identified. The technician responsible was working the night shift, and no supervisor was present. Consequently, when correcting the etching data, the technician inadvertently copied the data from a different part number.

There was a lack of thorough verification of the etched contents on the actual product. At the initial end inspection, there was no procedure in place to verify the accuracy of each character on the check sheet, resulting in oversight.

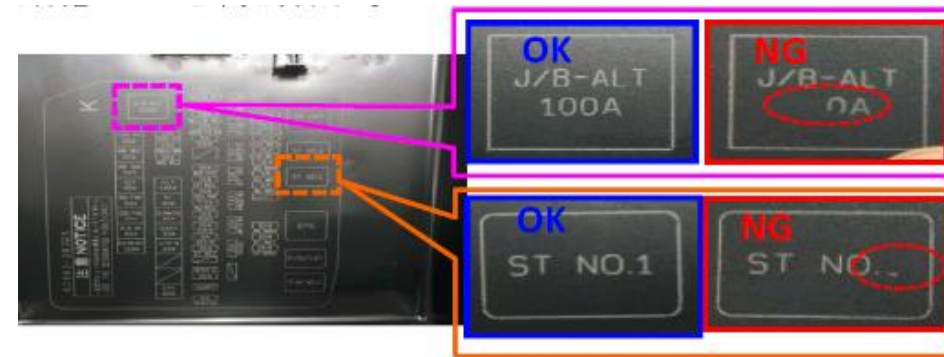
2. CASE STUDY 2

Defect : Lack of character

Defect quantity : 1 piece

The laser diode experienced overheating caused by a malfunction in the chiller pump responsible for cooling. The machine faced frequent interruptions due to equipment malfunctions; however, because the aging equipment was sourced from overseas, the repair was not possible.

The installed camera inspection machine lacked the capability to detect a missing character measuring 1 mm. This highlights the inadequacy in verifying the accuracy of the camera inspection machine.

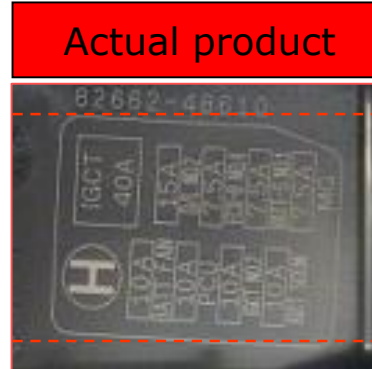
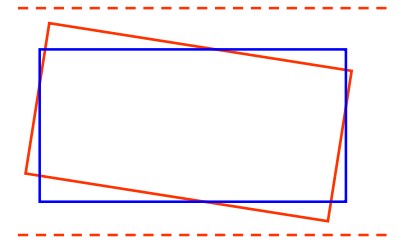
2. CASE STUDY 3

Defect : Slanted etching

Defect quantity : 1 piece

The jig design for securing the resin component was inadequate, allowing the component to be positioned in a floating state during etching. This lack of stability led to the etching of the component while it was in a floating state. Furthermore, there was no sensor in place to detect when the component was in a floating state.

The camera inspection machine was unable to detect slanted etching due to its limited coverage, which only inspected a portion of the etched area.

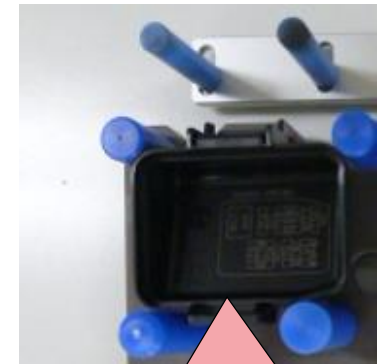
The cover floated and set.

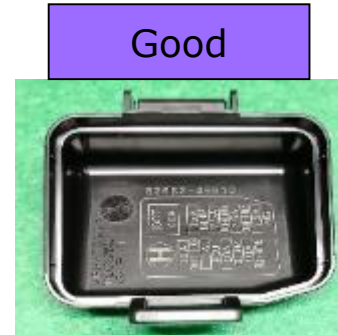
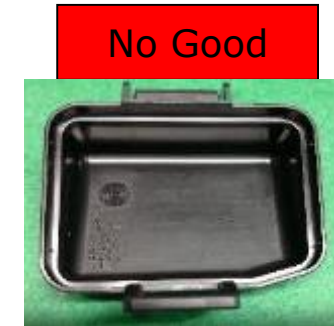
2. CASE STUDY 4

Defect : No etching

Defect quantity : 1 piece

The workload increased as a result of heightened production due to the impact of Covid. Unprocessed products that were placed on the workbench were inadvertently placed into the finished goods box, leading to skips in the etching process.

Products with skipped processes were released due to an incomplete quantity match with the machine counter.

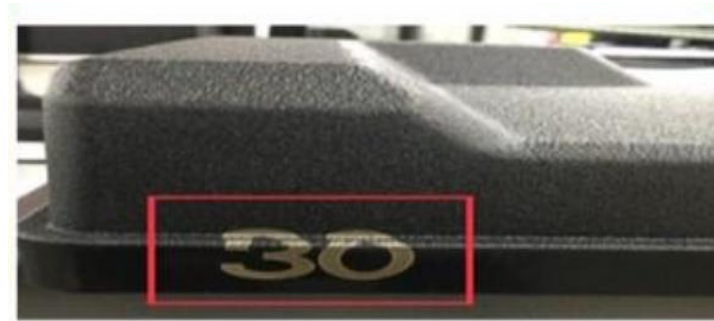
2. CASE STUDY 5

Defect : Incorrect etching position

Defect quantity : 1 piece

The detection sensor was misaligned, preventing it from detecting when the resin component was out of position.

The defect had never occurred previously, leading to the oversight in inspection instructions that did not include checking for side etching.
