**APQP Phase - PAST PROBLEM HISTORY (PPH)
(PAST QUALITY PROBLEMS)**

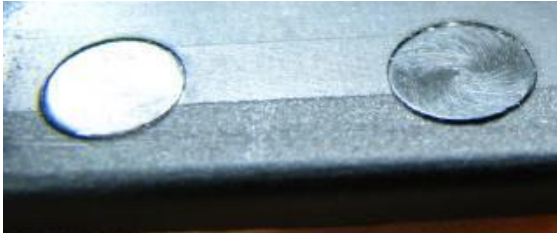
Item No.	Reference Information	Description	Example Picture
1	Plastic Components	Flash (Burr)	Functional area: None Handling area: 0.3mm or less Others: 0.5mm or less
2	Ejector Pin Marks	Excessive flash

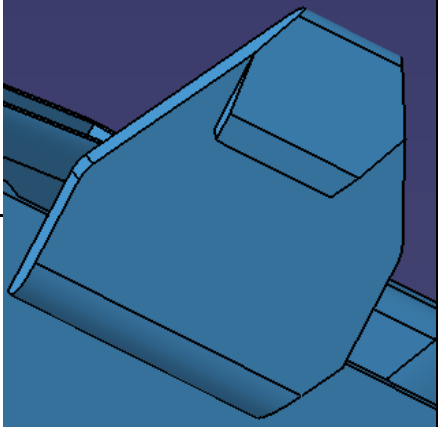
Item No.	Reference Information	Description	Example Picture
8	Male Locking Feature	Excessive flash

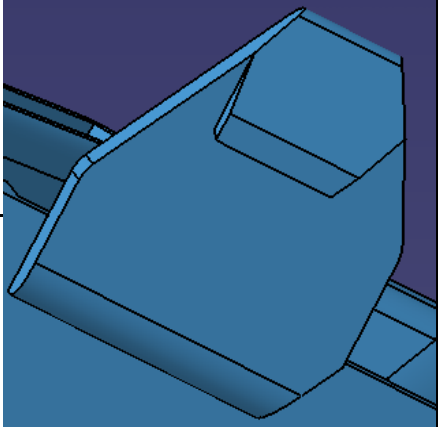
9	Male Locking Feature	Lock was found to have incorrect shape

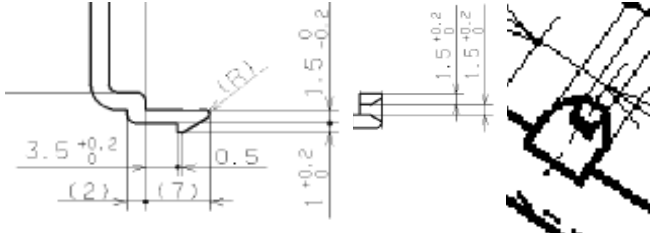
10	Male Locking Feature	High insertion force, low retention force

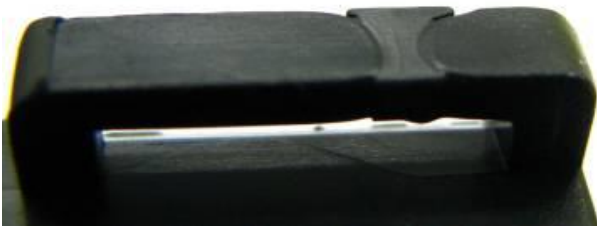
12	Female Locking Feature	1. Weld line on the female lock 2. Broken lock at engagement

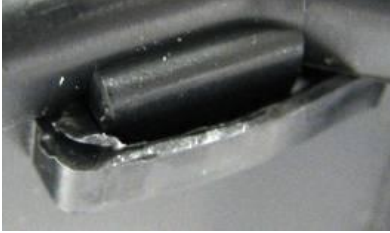
13	Female Locking Feature	Locks do not engage properly

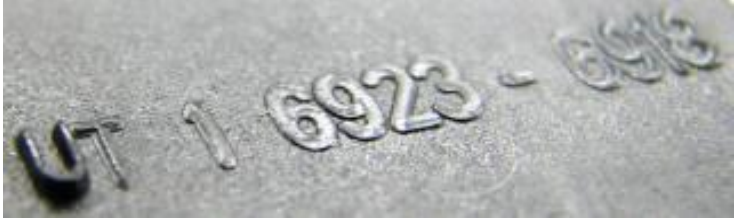
15	6923-6918 PROT134RP6	Supplier ID and part number engraving NG

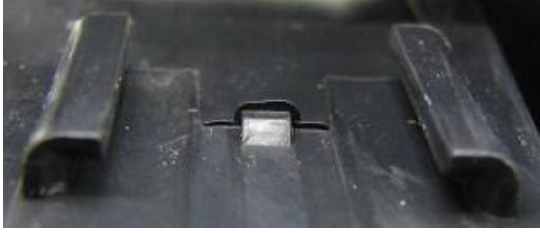
17	J/C connector	Flash on the mating feature

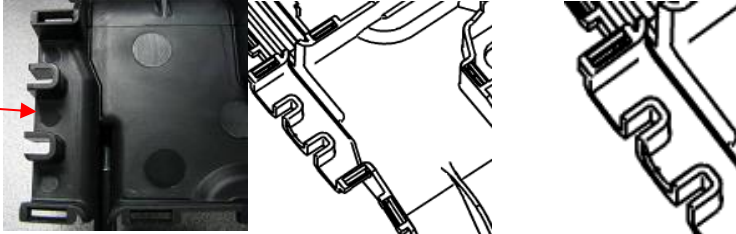
18	6923-7816 PROT133R8A	Rib is missing

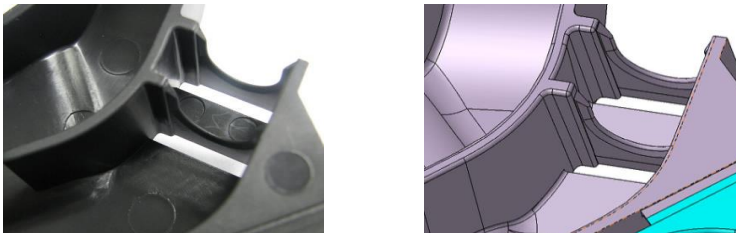
19	corrugate tube holder	*Picture right is good sample part, but this is a reminder that corrugate rib cannot bemissing

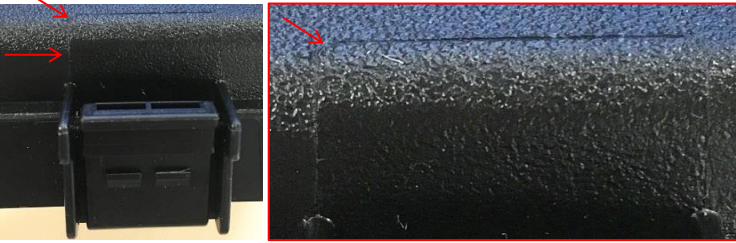
Item No.	Reference Information	Description	Example Picture
26	RB Upper Cover 63514659, 63514660 (Without etching 63514565)	Parting line on the surface where parting line is prohibited.

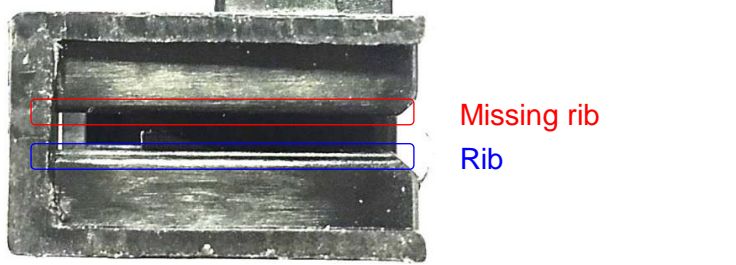
26	69240962 PROT1385WJ-1	Missing rib feature

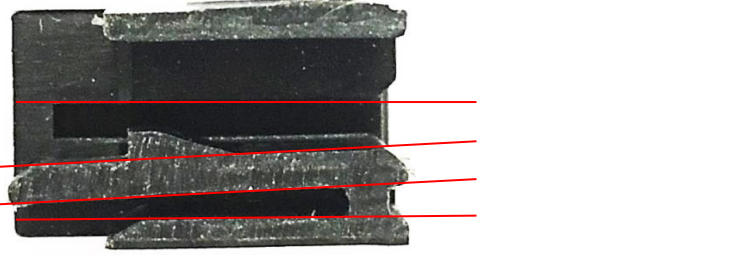
27	69240962 PROT1385WJ-1	Warping bracket lock feature

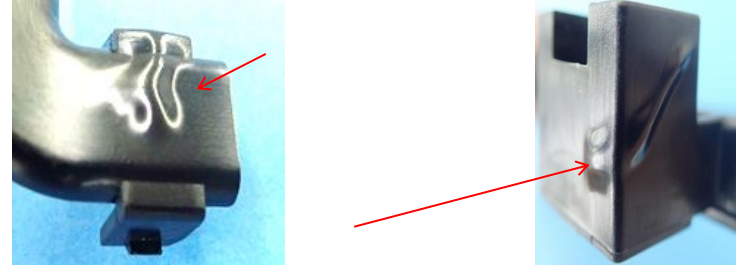
28	69240962 PROT1385WJ-2	Severe sink mark

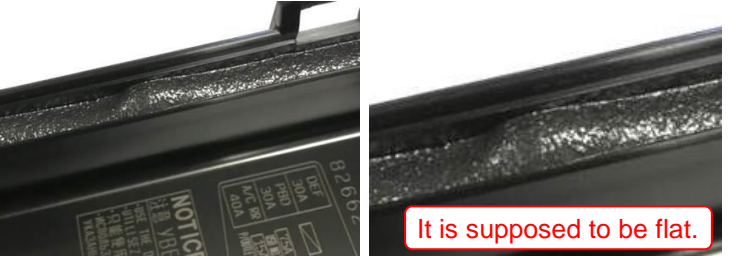
29	RB UPPER COVER 63514903 63514904 63514905 (Without etching 63514906)	Bump on the foam installed in the RB cover

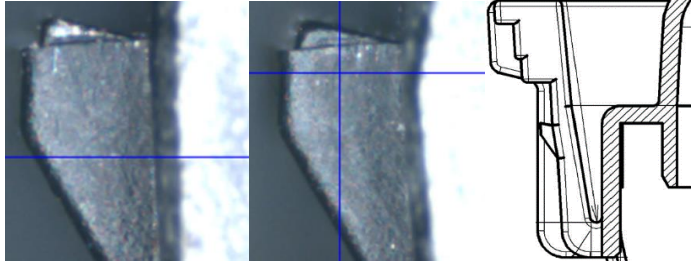
Item No.	Reference Information	Description	Example Picture
30	RB UPPER COVER 63514903 63514904 63514905 (Without etching 63514906)	Incomplete make lock feature

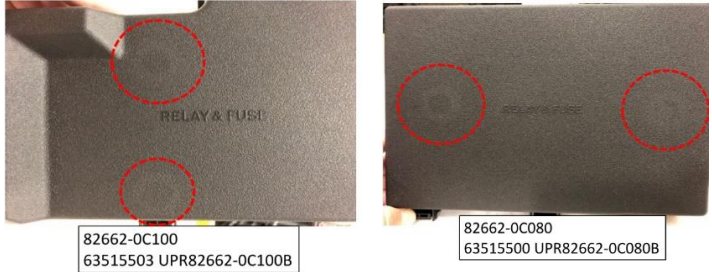
32	CEGS-RFIC-004	Toyota TMMTX issued a complaint about round marks on the texture that are visible and are not an acceptable condition for the upper side of the relay box cover. The texture area must be free of any mark or scratch.
