Laser Etching Past Quality History

Wire Harness Production Management Business Unit
Quality Assurance Department
Supplier Quality Department
Component Evaluation Group
3/6/2024

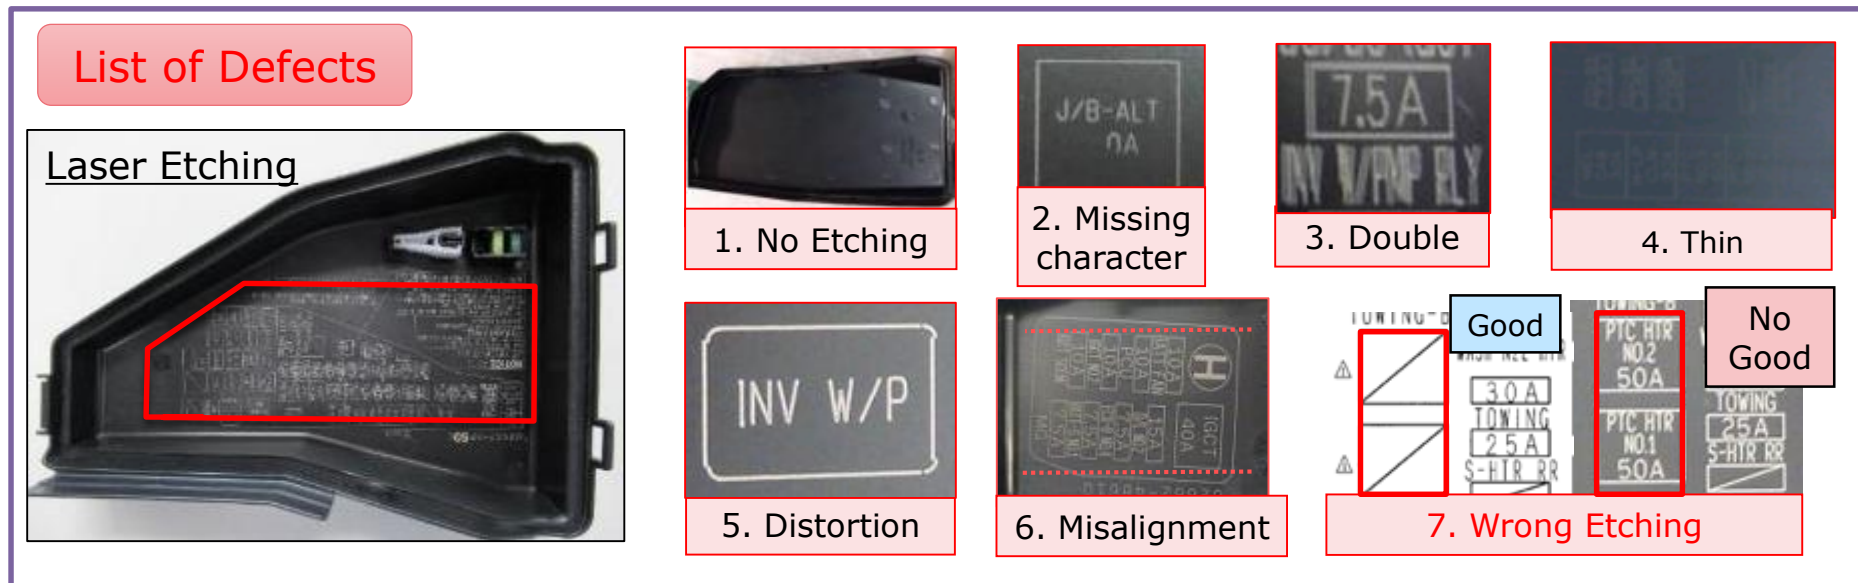
- RB upper covers are supplied directly to automobile manufacturers, and given that defects in these covers may impact safety regulations concerning running, turning, and stopping, there is a considerable potential for this to evolve into a substantial quality concern.
- For instance, if a 20A fuse is erroneously labeled as a 25A fuse, end users or dealers may install the incorrect fuse. In case of a circuit malfunction, the fuse may not blow, resulting in heat buildup and fire hazards, posing a critical issue.
- Hence, it is imperative to ensure a dependable process assurance in the production of RB upper covers.

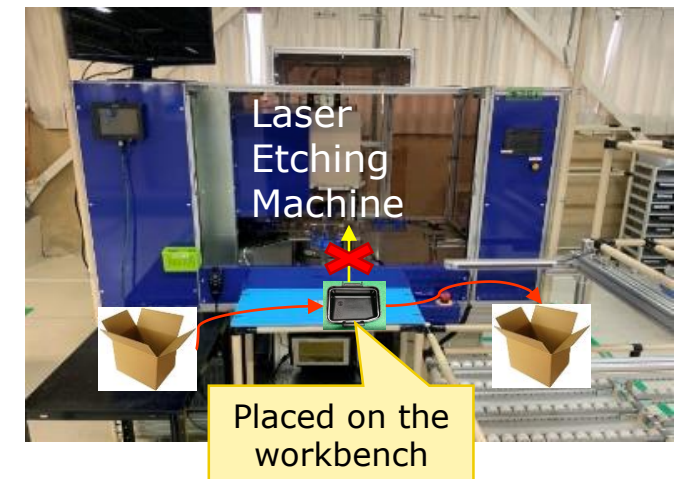
Cause of occurrence

The workload increased as a result of heightened production due to the impact of Covid. Unprocessed products that were placed on the workbench were inadvertently placed into the finished goods box, leading to skips in the etching process.

Cause of the Flow-out

Products with skipped processes were released due to an incomplete quantity match with the machine counter.
